Manhole Inspection Summary

Manhole # S19I1_023MH

Insp Date: **4/18/08 12:35 PM**

Location Address: **2436 harriett av**

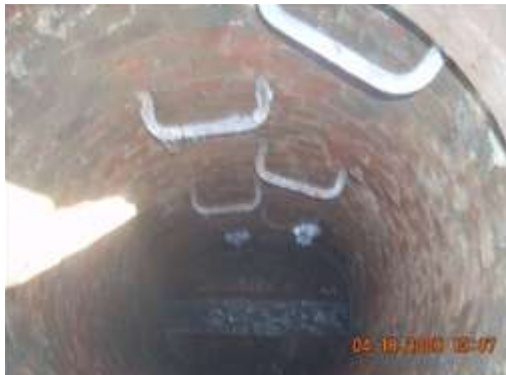
Defect 5

Steps Count: **8** Missing: **0** ☒ **Corroded**

corroded steps

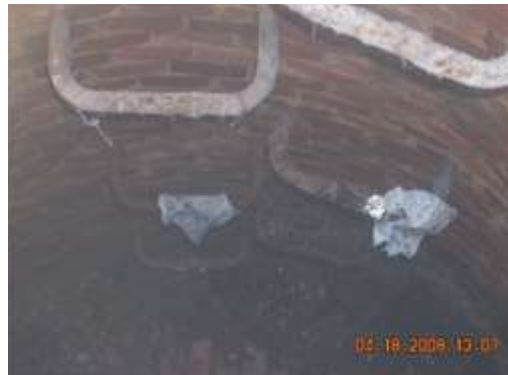
Defect 4

Surcharge ☒ **Evidence Of Surcharge** Depth: **6** (ft.) ☐ Active Surcharge Present

surcharge evidence

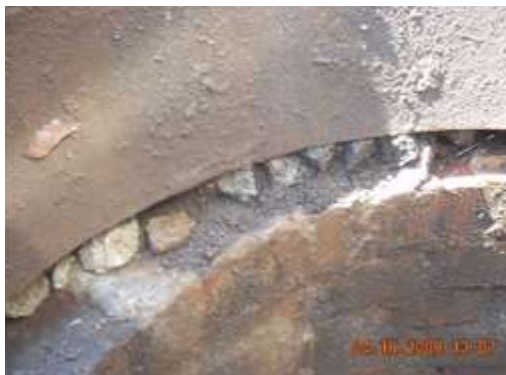
Defect 3

Condition: ☐ Sound ☐ Cracked ☐ Root Intrusion ☐ Loose Brick ☒ **Deteriorated**

deteriorated chimney

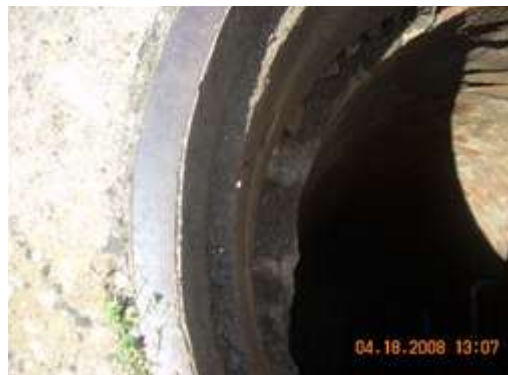
Defect 2

Frame Offset: **2** (in.) Condition: ☒ Sound ☐ Cracked ☐ Leaks

frame offset

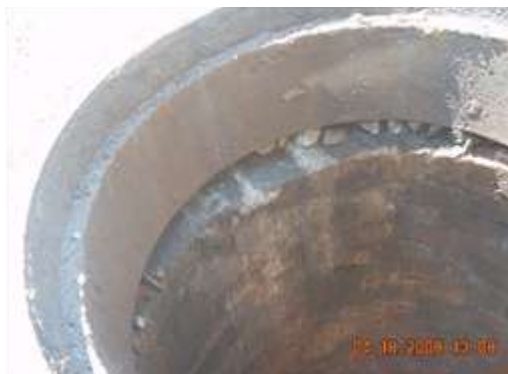
Defect 1

Infiltration: ☐ None ☒ **Joint** ☐ Cracks ☐ Mortar ☐ Roots ☐ Wall

inflow evidence @ chimney/frame joint

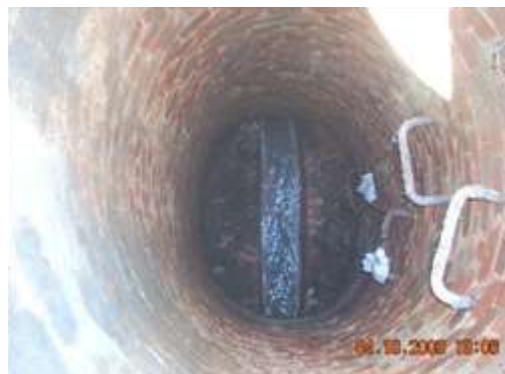
Defect 6

Condition: ☐ Sound ☐ Cracked ☐ Root Intrusion ☐ Deteriorated ☐ Leaks ☒ **Debris**

bench cond debris

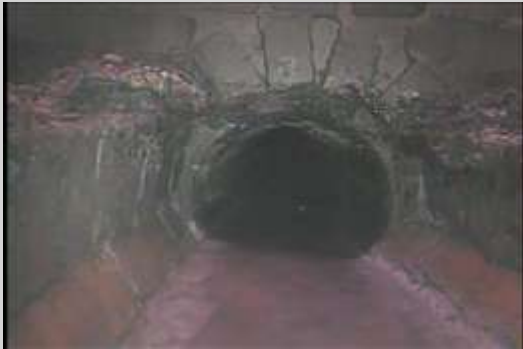
12 O'Clock Outflow

Pipe Height: **9.6** (in.) Rod and Bar (Angled)
Pipe Material: **Clay** ☐ Pipe Lined
Invert Depth: **12.74** (ft.) Flow Characteristics: **Slow**
Deposits: ☒ None ☐ Mud ☐ Sludge ☐ Debris ☐ Grease
Silt Depth: **0** (in.) Deposits Extent:
Infiltration: **Evidence** Pipe Seal Cond: **Sound**
